## Standardizing a Test Method for Conductive Anodic Filament Growth Failure

Clarissa Navarro  
Isola

### Abstract

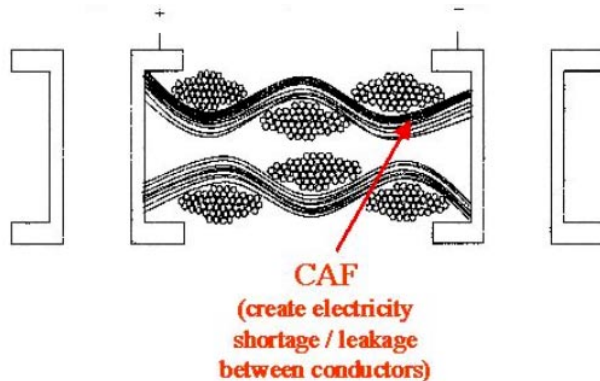
Figure 1 – Through Hole-Through Hole

Conductive anodic filament (CAF) failure is the growth or electromigration of copper in a PCB. This growth typically bridges two oppositely biased copper conductors. This failure can be manifested in four main ways: through hole to through hole, line to line, through hole to line, and layer to layer. The most common failure mode is hole to hole.<sup>1,2</sup> See Figures 1, 2, 3 and 4.

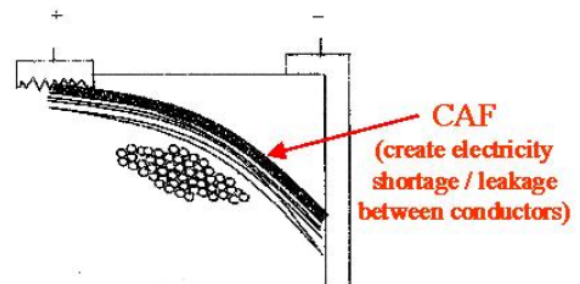
Figure 3 – Through Hole-Line

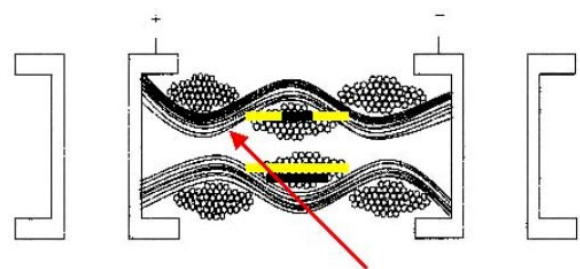
Figure 4 – Layer-Layer

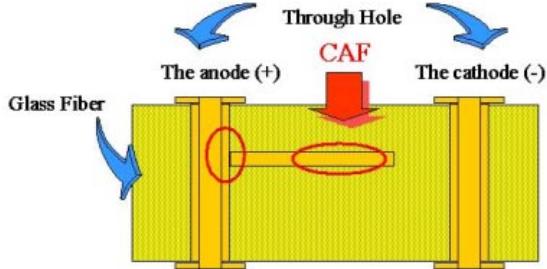
Figure 5 – A Short

It is known that a combination of bias voltage (voltage applied during the test) and high relative humidity (RH) can cause a CAF failure during testing. The electrical failure is caused when a filament grows from a copper anode to a copper cathode. This is most likely due to a chemical reaction that occurs when moisture in the epoxy, ion migration and corrosion of the silane bond takes place. This will result in a short<sup>2</sup> (see Figure 5).

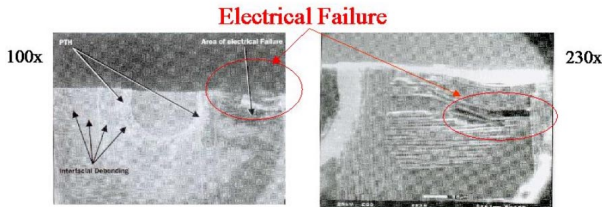
Figure 6 – Deformed & Cracked Epoxy Resin; Broken Glass Fiber

There are several material conditions that have been attributed to causing a material to be more or less resistant to conductive failures. They are grouped into three categories; glass, resin and treating. Glass finish, hollow fibers and cleanliness need to be tested. Resin purity, the cross linking agent and moisture absorption characteristics are significant. Treating parameters for wetout (good resin/glass interface) and cleanliness are also important.<sup>4,5,6,7</sup> See Figure 6 and Figure 7.

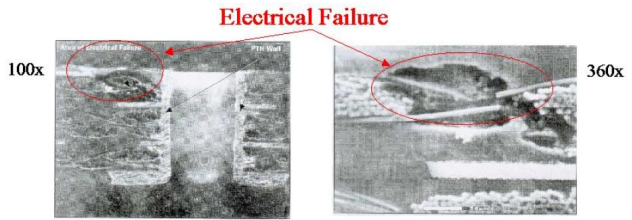
Figure 7 – Vaporized Epoxy Resin; Broken Glass Fiber

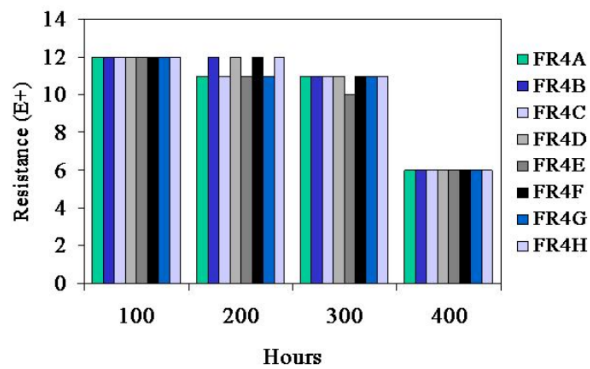
Figure 8 – FR4 CAF Failures

The initial testing accomplished at Isola was with a very simple all 7628 prepreg four layer (this was considered to be a “ worst case ” material construction due to the heavy glass and small drilled hole size). The hole to hole spacing was 0.024 inch, with rows along the X plane, the Y plane and diagonally. A variety of generic FR-4 materials were tested. The boards were all manufactured at the same time. The drilled hole size was 0.0135 inch. Half of the boards had solder, half had bare copper. (The influence of flux and soldering has had detrimental effects on CAF resistance.)<sup>5</sup> Figure 8 shows that all FR-4 epoxy boards failed at 400 hours under the following test conditions.

85% RH  
 85°C  
 13 VDC bias voltage  
 100 VDC test voltage at every 100 hours (Coupons were removed from the chamber and allowed to stabilize to ambient prior to testing.)

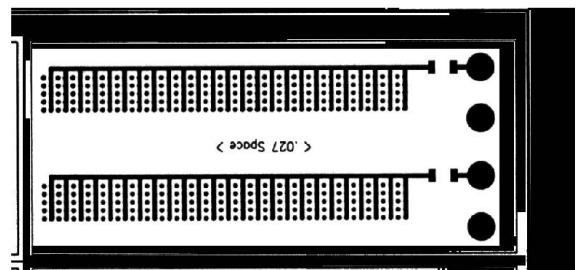
Figure 9 – CAF Failure Analysis Coupon

These coupons were mounted into a quick curing epoxy for grinding. The first coupon was ground in the X plane. It was inspected carefully at each layer of grinding to ensure that the copper was not missed (ground through) if it was present. Using this method, one copper spot was found. Unfortunately, we could not verify that it was an actual copper short, because the grinding plane was wrong (see Figure 9).
